# LIQUEFACTION IMPACTS IN RESIDENTIAL AREAS IN THE 2010-2011 CHRISTCHURCH EARTHQUAKES

**ABSTRACT:** In 2010 and 2011, the city of Christchurch (New Zealand) was hit by a sequence of strong, local and devastating earthquakes. Widespread and very severe liquefaction affected many of the city suburbs and its central business district. This paper summarizes the characteristics of liquefaction and discusses its impacts on residential houses and buried pipe networks.

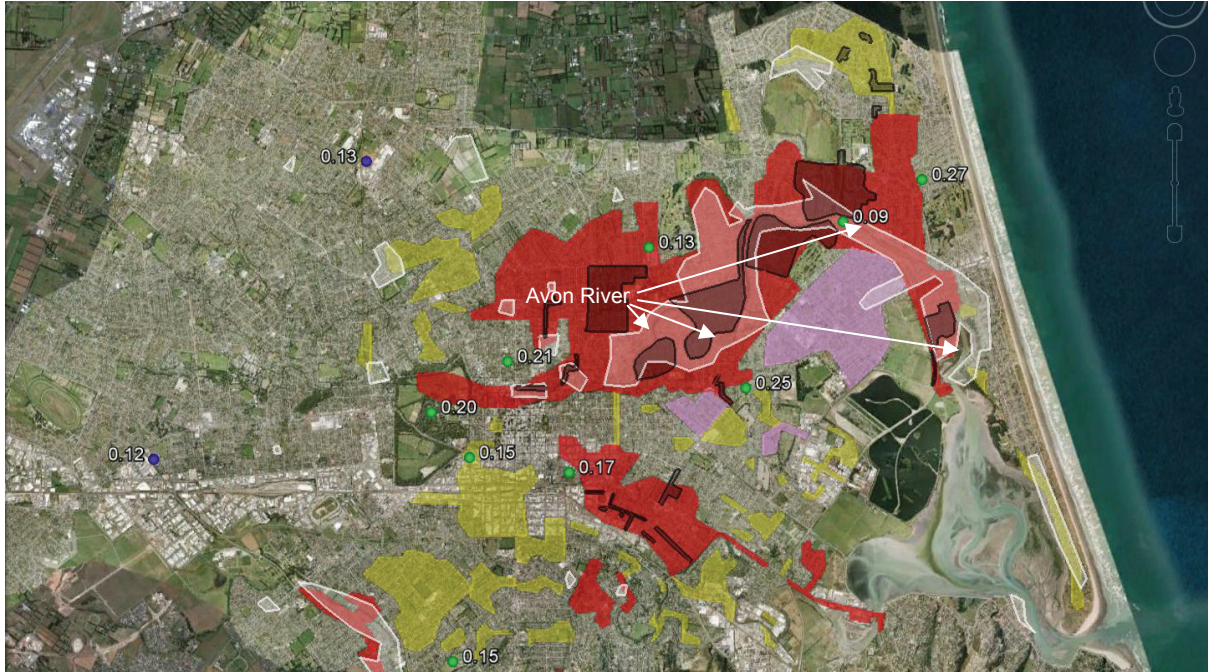
Fig. 4 Liquefaction maps indicating areas of observed liquefaction in the 4 September 2010 (white contours), 22 February 2011 (red, yellow, magenta areas), and 13 June 2011 (black contours) earthquakes; normalized cyclic stress ratios at water table depth,  $CSR_{7.5(wt)}$ , which were calculated using the recorded geometric mean peak ground accelerations and respective earthquake moment magnitude are also shown (green symbols indicate strong motion stations where the 22 February 2011 produced the highest  $CSR_{7.5(wt)}$  value whereas the 4 September 2010 earthquake produced the highest  $CSR_{7.5(wt)}$  value at the SMS depicted with blue symbols)

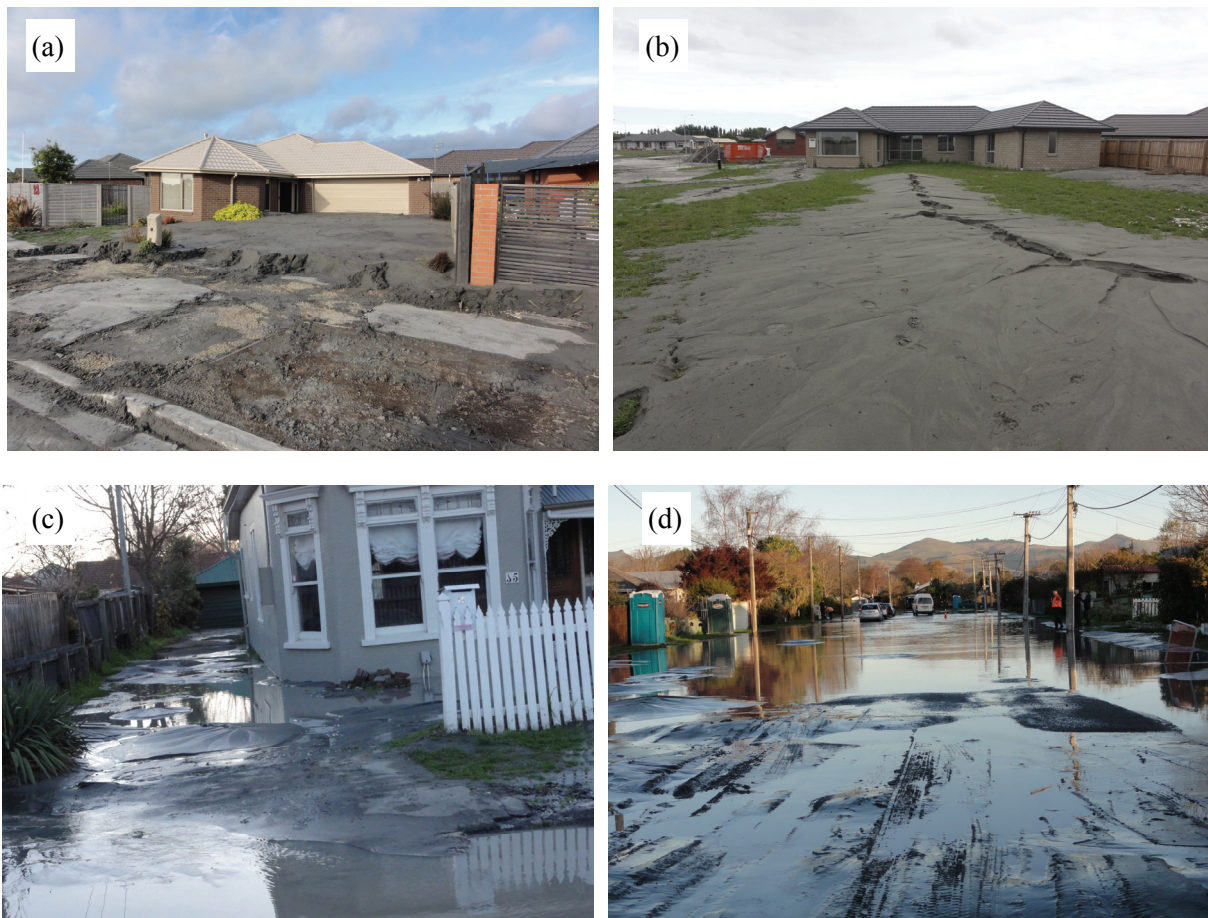
Figure 6 illustrates typical manifestation of severe liquefaction in the eastern suburbs of Christchurch. There was widespread and very large in volume (thickness) sand/silt ejecta covering the residential properties and streets in these suburbs. In numerous cases the entire area of the property was covered by 50-60 cm thick silt/sand ejecta (Figure 6a), and massive in size sand boils (Figure 6b) indicated very severe (and often extreme) liquefaction of loose to very loose soils highly susceptible to liquefaction. In the worst affected areas, extreme liquefaction with mud and water flooding entire streets and adjacent properties and even larger neighborhoods encompassing several streets within a suburb. Following the 22 February 2011 earthquake, over 400 000 t of silt/sand ejecta was removed in the clean up of streets and properties which indicates both the extreme severity and extent of the liquefaction. While the 22 February event caused in most cases the most severe liquefaction, a complete flooding of streets and very severe liquefaction occurred in these areas also during other earthquakes, as illustrated in Figures 6c and 6d where substantial sand boils and effects of liquefaction are seen in Avonside and Avondale after the 13 June earthquakes.

Fig. 6 Severe liquefaction in residential areas (suburbs along Avon River in the abandoned “red zone”)

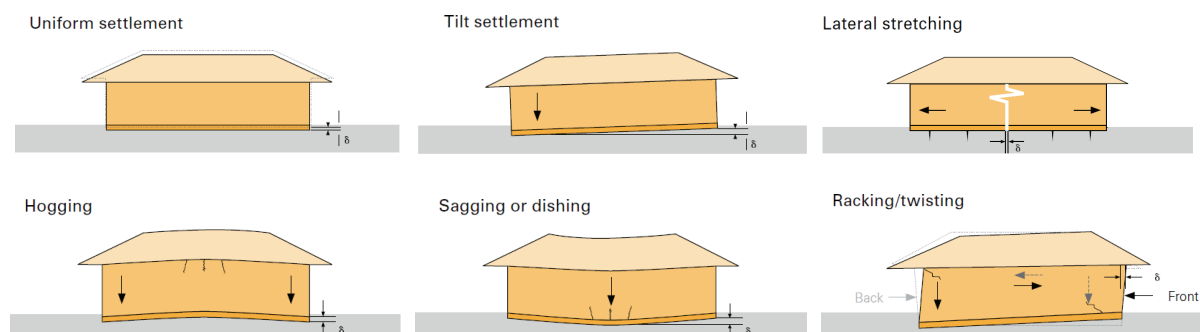
Approximately 20,000 houses were seriously affected by liquefaction, out of which more than 6,000 have been damaged beyond economic repair (in the abandoned areas suffering extensive liquefaction). The worst damage to residential houses was inflicted in areas where severe lateral spreading occurred, however, liquefaction on its own, even in the absence of lateral spreading, caused extensive and often substantial damage beyond economic repair. Some typical damage patterns of house foundations are schematically illustrated in Figure 8 (DBH, 2011).

Fig. 8 Schematic plot of typical damage patterns for house foundations (DBH, 2011)

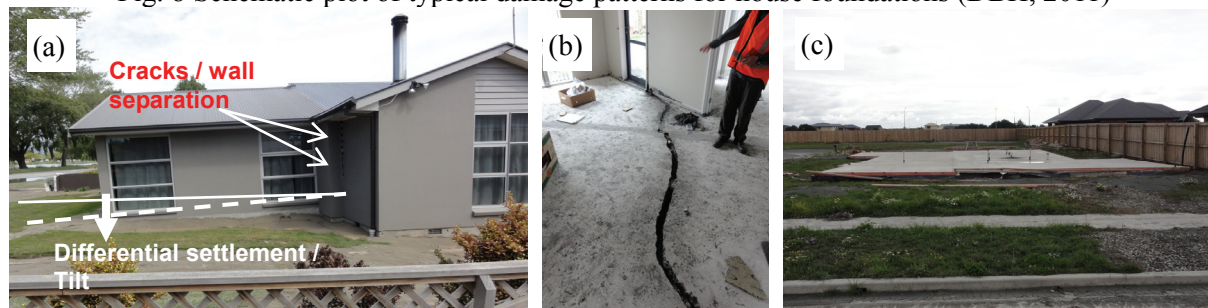
The liquefaction often led to large global and differential settlements. In the worst cases, the total (global) settlement exceeded 40-50 cm. Differential settlement resulting in permanent tilt of houses and often causing foundation and structural damage (Figure 9a) was the most common mode of deformation for both foundation types. Concrete slabs suffered serious damage including wide cracks (Figure 9b), and non-uniform deformation such as dishing (sagging) and hogging. Figure 9c shows a characteristic dishing of a newly constructed slab on grade which was affected by heavy liquefaction in the foundation soils. A number of different deformation modes could be identified for the perimeter

Fig. 9 Observed typical liquefaction-damage to house foundations: (a) differential settlement resulting in tilt and damage to house; (b) large crack in a concrete slab; (c) dishing of concrete slab on grade

footing foundations including humping of floors (often in individual rooms) due to larger settlement beneath the heavier walls, dishing caused by heavy brick chimneys founded on isolated footings in the interior of the floor plan, and racking/twisting of the superstructure caused by differential settlement/movement of corners/parts of the foundation due to its inadequate stiffness.

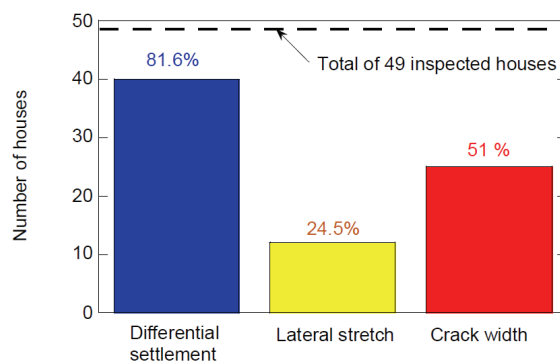
Fig. 11 Summary of damage to concrete perimeter foundations (49 inspected houses in Christchurch) indicating percentage of foundations exceeding the DBH no-damage criteria listed in Table 2

The 49 inspected perimeter footing foundations were scrutinized against the DBH damage criteria listed in Table 2. Since most of these foundations/houses were old (pre 1930, 1930-1959, 1960-1979) and of poor quality (often without any reinforcement), they suffered very high proportion of damage: 82% had tilts exceeding 1/200, 25% had total width of cracks exceeding 20mm and 51% max width of a single crack over 5mm. The damage for these foundations was poorly related to the liquefaction severity, and 8 foundations showed damage greater than at least one of the criteria listed in Table 2 despite being located in areas of no liquefaction.

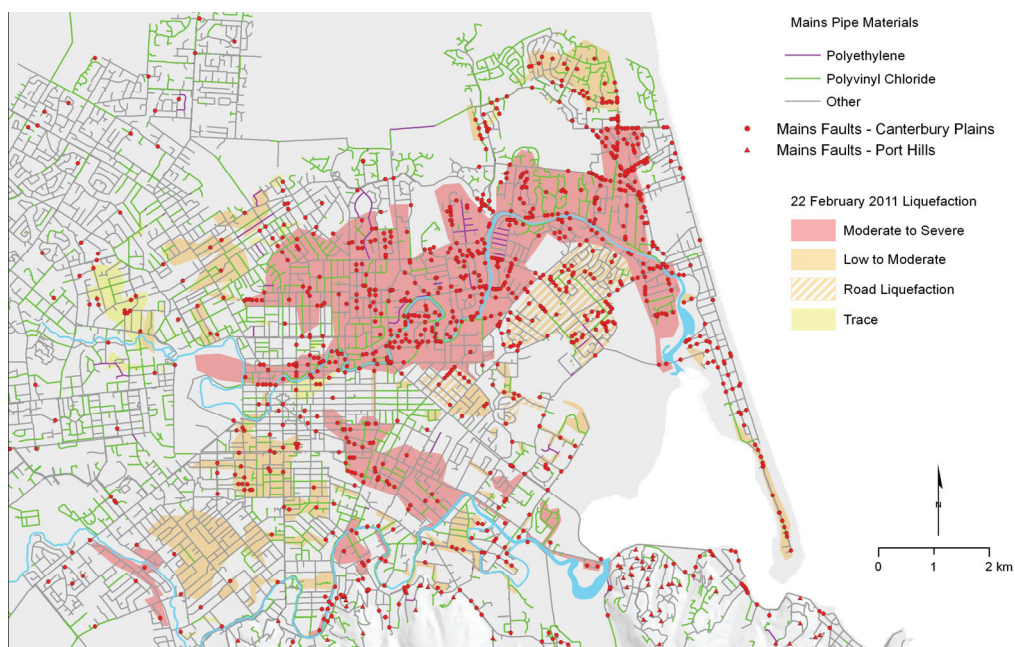
Figure 12 shows the location of repairs/faults on the watermains network (red symbols) following the 22 February 2011 earthquake. Superimposed in the background of the figure (with red, orange and yellow colours) is the liquefaction map (Cubrinovski and Taylor, 2011) indicating the severity of liquefaction (and associated land damage) induced by this earthquake. Preliminary GIS analyses (Cubrinovski et al., 2011) using the pipe network damage data and liquefaction observation maps show a clear link between the damage to the pipe network and liquefaction severity. Approximately 58% of the damaged pipes were in areas of moderate to severe liquefaction, 20.2% were in areas of low to moderate liquefaction, 2.5% in areas where traces of liquefaction were observed and 19.3% in areas where no signs of liquefaction were observed.

Fig. 12 Liquefaction map and locations of damage to the potable water network of mains (red symbols) of Christchurch due to the 22 February 2011 earthquake (Cubrinovski et al., 2011)

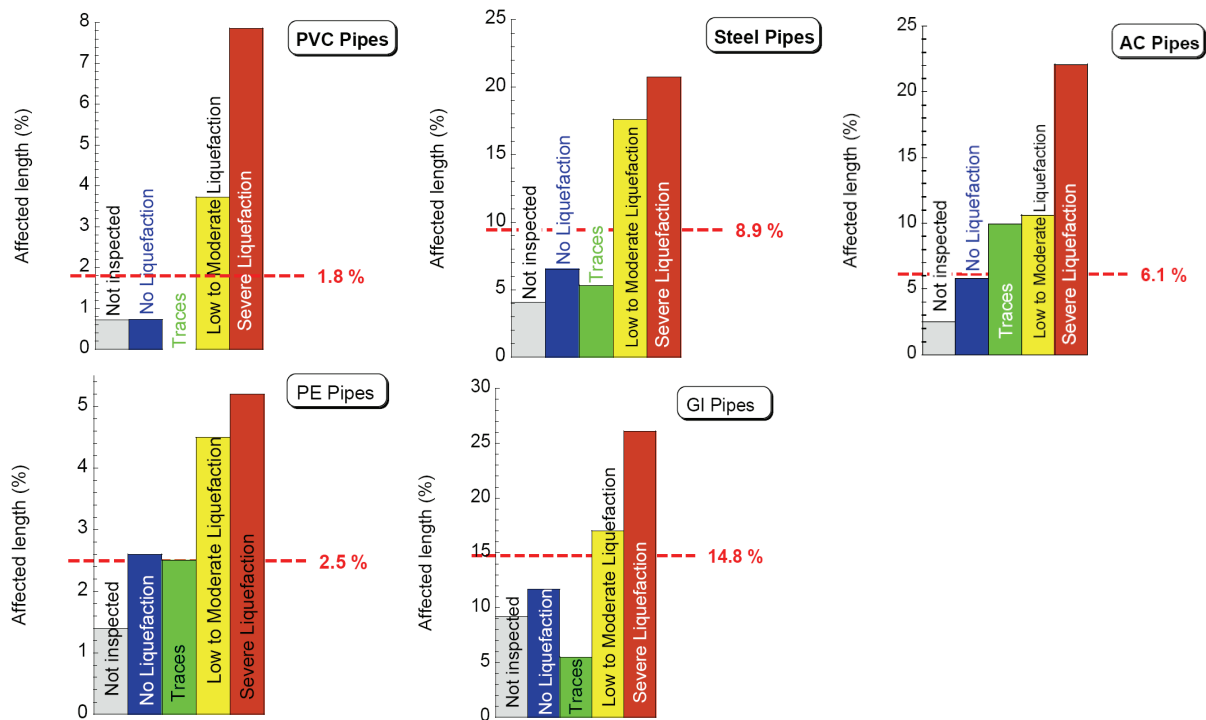
The analyses also revealed that PE pipes and PVC pipes suffered significantly less damage (three to five times less on average) than AC, steel, GI and other material pipes. Figure 13 summarizes the performance of different pipe materials (PVC, steel and AC pipes for the watermains; PE and GI pipes for the submains) and clearly indicates the difference in the performance of different pipe materials and the increase in the pipe network damage with increasing liquefaction severity.

Fig. 13 Summary of damage to water pipes due to the 22 February 2011 earthquake indicating performance of different materials in relation to liquefaction severity: Water mains: (a) PVC, (b) Steel, (c) Asbestos Cement pipes; Submains: (d) PE, (e) Galvanized Iron pipes
